DEPARTMENT OF TRANSPORTATION**DIVISION OF ENGINEERING SERVICES**

Contract #: 04-0120F4Cty: SF/ALA Rte: 80 PM: 13.2/13.9File #: 1.28**WELDING INSPECTION REPORT****Resident Engineer:**Pursell, Gary**Address:** 333 Burma Road**City:** Oakland, CA 94607**Report No:** WIR-016404**Date Inspected:** 23-Aug-2010**Project Name:** SAS Superstructure**OSM Arrival Time:** 1000**Prime Contractor:** American Bridge/Fluor Enterprises, a JV**OSM Departure Time:** 1830**Contractor:** American Bridge/Fluor Enterprises, a JV**Location:** Job Site

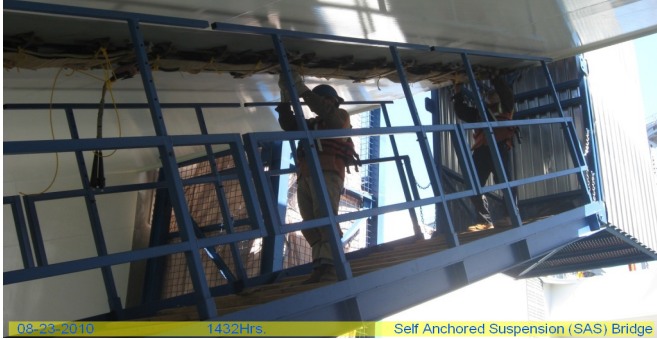
At OBG 5W/6W side plate 'E' outside, ABF welder Songran Huang and company were noted installing the heater blankets of the Miller Proheat 35 Induction Heating System from the outside but will perform the 3G FCAW-G welding from the inside.

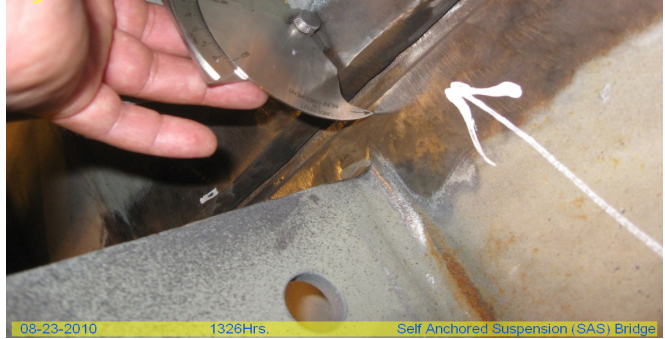
At OBG 5W/6W side plate 'E' inside, fit-up misalignment of 4.0mm was noted during the QA verification. QC acknowledged the misalignment and instructed the fit-up crew to fix the unacceptable high/low.

At OBG 5W/6W side plate 'E' inside, ABF QC William Sherwood has confirmed the existence of fit-up misalignment of the splice joint. He then instructed the fit-up crew to fix the unacceptable misalignment. Later, the fit-up crew was noted hammering the rod inserts of the fitting gears to make the adjustments. QC has re-measured the high/low and has come to acceptable level. QA has also verified the alignment after the adjustment.
